GROUP: 23 - Body

Water Leaks At Sliding Backlite

2019 - 2020

RAM 1500 Pickup

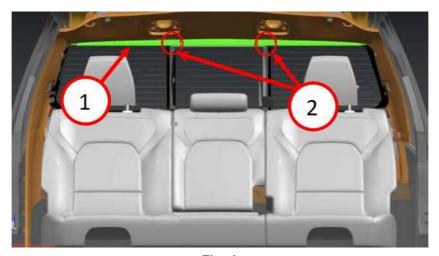
Fig. 1
Inside Truck Cab

1. Inspect the rear sliding glass assembly from inside the cab, looking for cracks in the frame (Fig. 1).

- 1 Upper Plastic Frame of Rear Sliding Glass Assembly (Green Area)
- 2 Potential Crack Locations
- 2. Were any cracks (Fig. 2) or evidence of leakage in rear sliding window frame found?

- YES>>> Proceed to Step 3 of the Repair Procedure.
- NO >>> This Bulletin does not apply. Normal diagnosis should be performed.
- 3. Replace the rear sliding glass assembly. Refer to the detailed service procedures available in DealerCONNECT> Service Library under: Service Info>23 Body / Stationary Glass / Backlite, Sliding / Removal and Installation.
